HP5065A Super upgrade

Ver. 1.4 June 2016

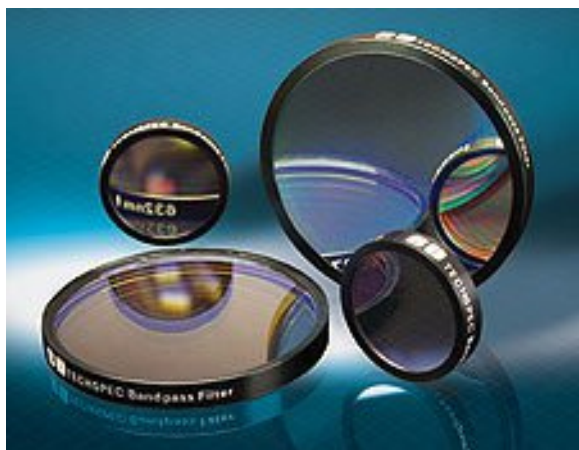
Edmund Optics Stock Number #65-178

The filter must have a low in band attenuation in and be cut to the 780nm that is the main emission frequency of the Rubidium. The filter used is manufactured by Edmund Optics, 25mm Dia., Hard Coated OD 4 10nm Bandwidth. Its price in Europe, including VAT and delivery charges is approximately 250 Euros.

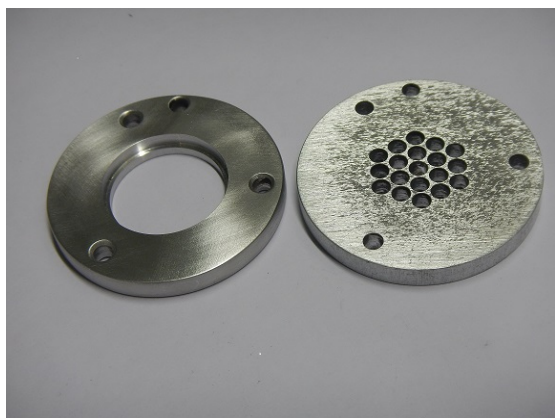
To install the filter some changes to the lamp cover assembly are needed to be modified to lock the lens in place. Figure 1 shows the modified piece and the original. Figure 2 shows the filter inserted.
